Ciudad de Mar removes aggregates accumulated in the natural pools of La Laja beach

By CDM

Tue Nov 07 13:01:31 WET 2017

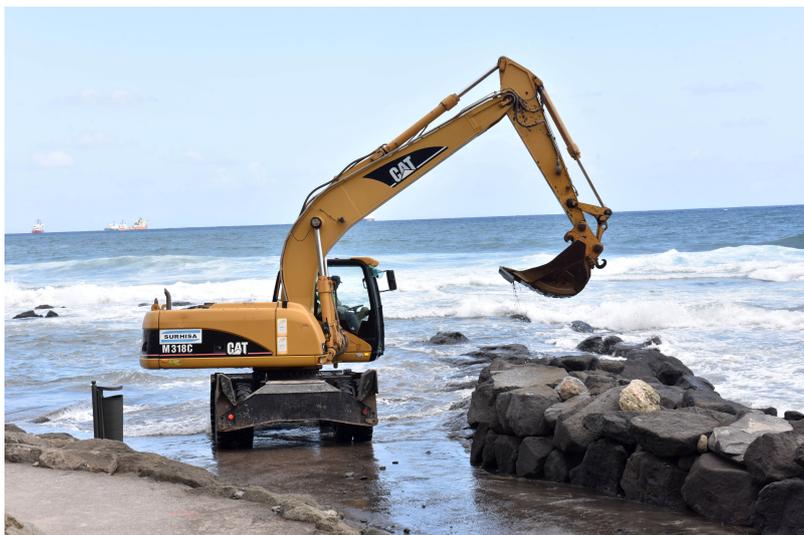
Ciudad de Mar, municipality of Las Palmas de Gran Canaria, has started this week to remove excess aggregates accumulated at the bottom of the natural pools of La Laja beach due to the coastal dynamics. The works that began in the morning of Monday, November 6, have allowed to recover the optimal state of this citizen leisure equipment that had lost depth. The pools will reopen to the public this afternoon.

The Demarcation of Coasts has authorized the execution of the works, awarded to the company SURHISA S.L., for which two backhoe loaders with an articulated arm and a loader have been used that have allowed to act on the bottom from the ends of the pools.
